TECHNOLOGY TRIAL STUDY EVALUATION

Technical Memorandum

RST-Cleantech USA, LLC

Document No.: 10247938-HOU-T-01-B

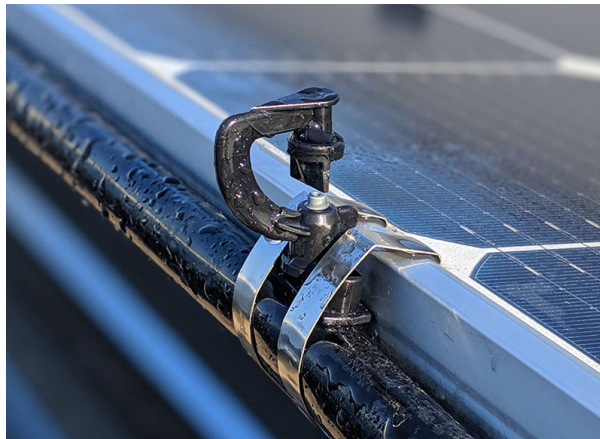
Figure 1-1: RST nozzle mounted on PV module frame (from Customer website)

According to the Customer, the solution achieves soiling mitigation through the spraying of water from custom nozzles mounted onto the metal frame along the top edge of tilted PV modules. The nozzles are designed with a 184-degree spray angle to ensure good water distribution across the lateral width of panels, allowing gravity to pull the water down and carry away light-blocking substances. For this pilot study, a washing event was programmed to occur only in the evening and utilizes approximately one (1) quart of filtered water per nozzle per wash. Polyethylene conduits carry water to the nozzles from an electrolysis filter that aims to remove minerals (such as calcium and magnesium) from the water, reducing potential fouling caused by hard water (see Figure 1-1 and Figure 1-2).

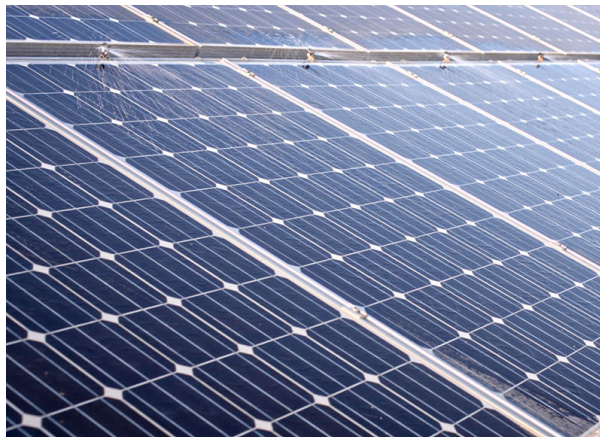
Figure 1-2: water spraying from nozzle onto modules (from Customer website)
